National Park Service  
Cultural Landscapes Inventory  
2013

Jordan and Sargent Mountain Carriage Roads  
Acadia National Park

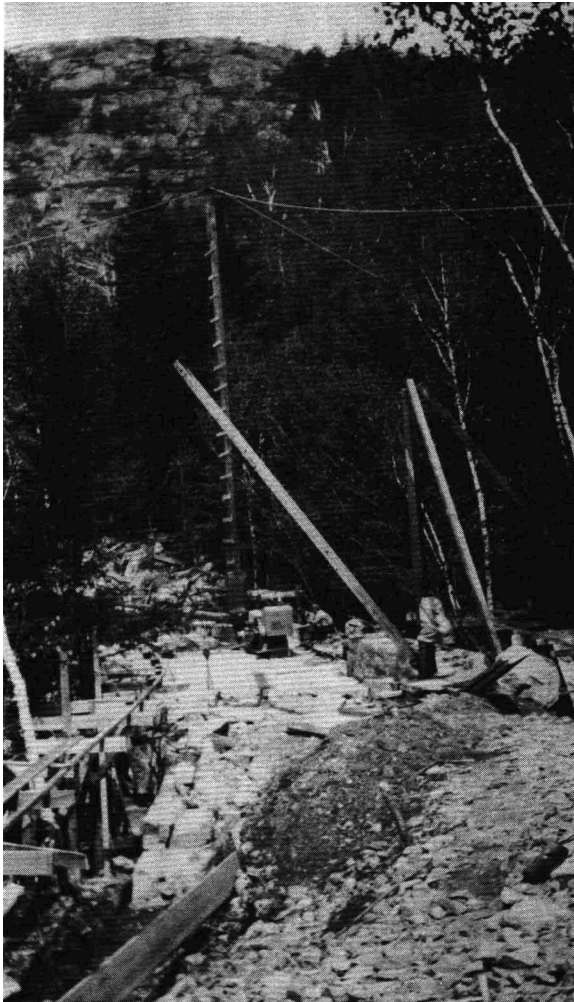
*Figure 4. The Waterfall Bridge under construction. Note the wood guides for the stonework on the left. (Mr. and Mrs. Charles P. Simpson Collection, from Historic Resource Study 1989:138)*

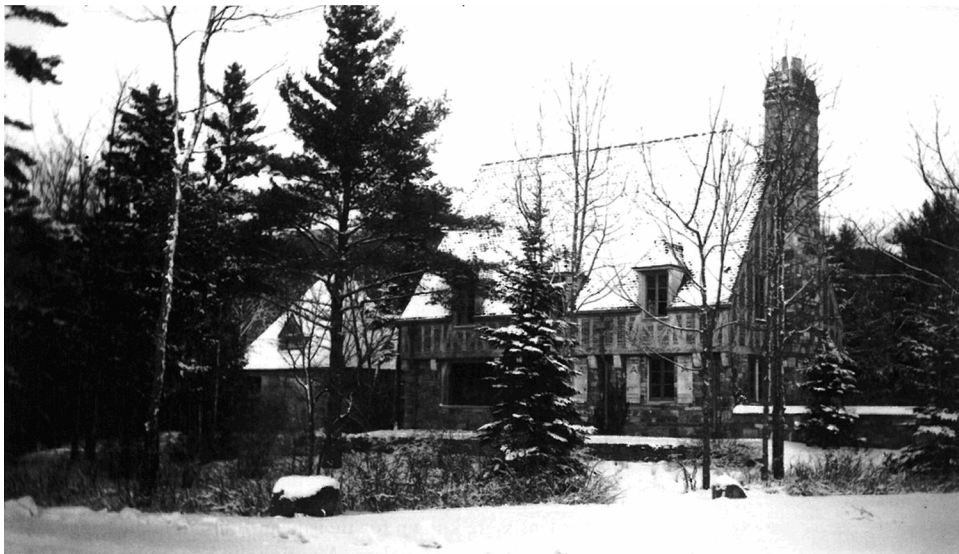
*Figure 6. View looking east at the Jordan Pond Gatehouse in 1934. (C.P. Simpson personal collection, from Roberts 2012: 165)*

The Brown Mountain and Jordan Pond gatehouses are 1930s examples of gate lodge architecture (Figure 6). Like their estate counterparts, they served the dual purposes of providing entrances to the carriage roads while also providing housing for the gatekeepers. When Rockefeller began thinking about a style of architecture for Acadia National Park, he funded a tour of western parks for prominent New York architect Grosvenor Atterbury in 1929 to find an appropriate building type. Since Acadia was still the only national park east of the Mississippi River at the time, the western parks (e.g., Yellowstone, Yosemite, etc.) were the only source of models. Atterbury, who had worked previously with Rockefeller and eventually designed both of Acadia's gatehouses, set down his findings in a report in 1929, which included valuable information about the early history of these western parks and also a clear statement of principles regarding architectural styles appropriate in a park setting. Atterbury subscribed to the view that man's intervention "...should not intrude on the experience of nature:" "However you derive it theoretically and stylistically, any Architecture in our National Parks is bound to be, in fact, the physical point of contact, comparison and contrast between the latest handiwork of human civilization and the oldest untouched monuments of Nature." (HRS 1989: 56, citing Atterbury 1929: 1)

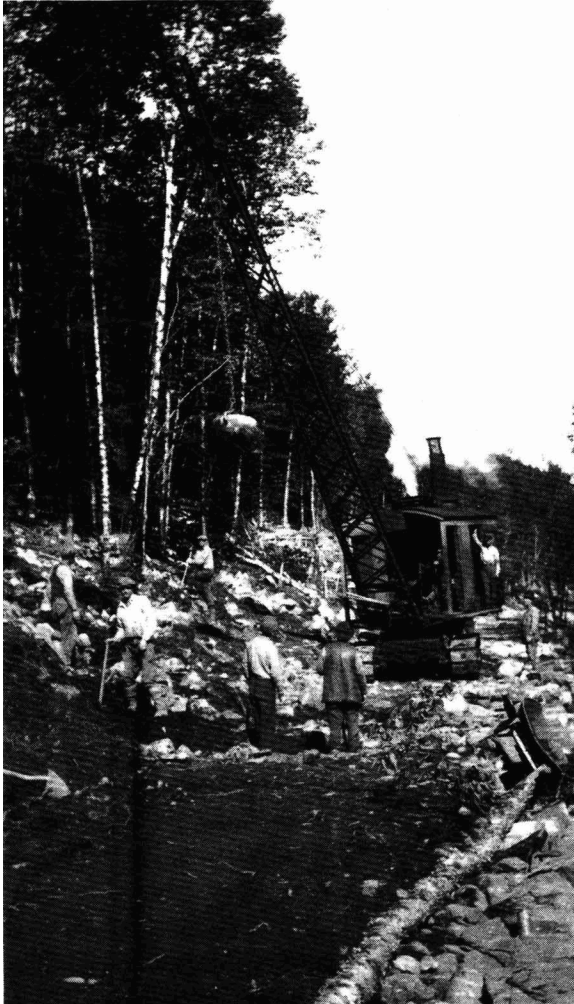
*Figure 14. Moving rocks with "dogs" on one of the carriage roads, no date. (Historic Resource Study 1989:295)*

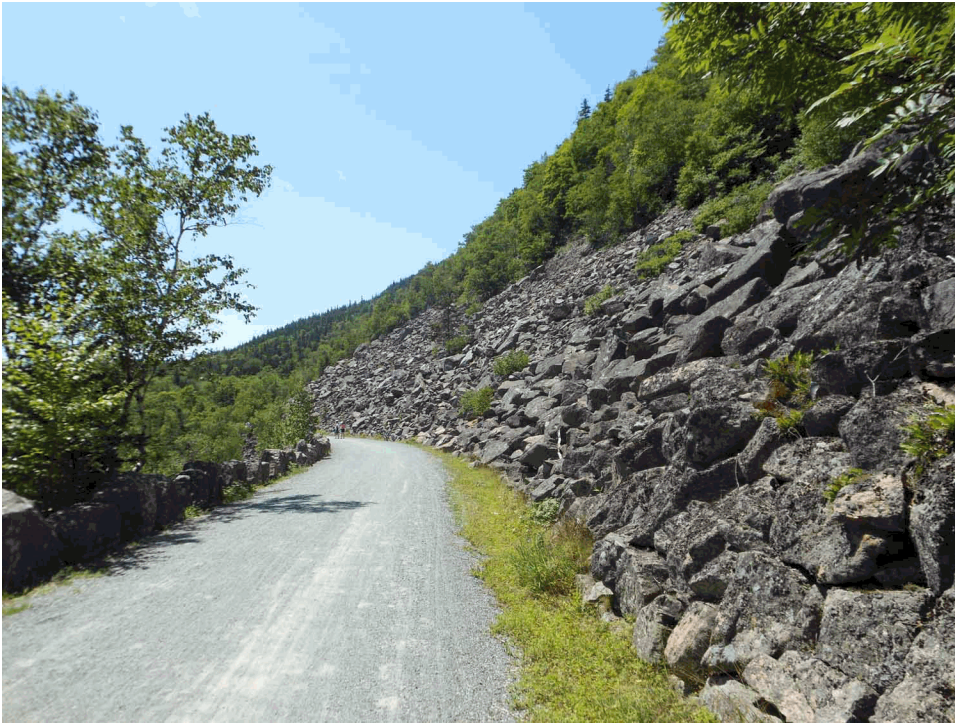
*Figure 19. Talus slope on CR 10s-14. (Trip 2, ACAD CR 10s-14\_17\_taluslope, DSCN0818, SUNY-ESF, 2012)*

The CLI Field School recorded general observations regarding natural systems and features (Figure 19). Historic path maps and current USGS maps of the island also provide good information about physical features, and Acadia's forests are thoroughly documented in the park's GIS database (Acadia NP, GIS: "veg1997final polygon"). An analysis of this information provided below indicates that Acadia's carriage roads still provide encounters with a wide variety of natural systems and features, and pass through forests diverse in composition and age. The orientation of the road and notable landforms, perennial and intermittent streams (abbreviated with a 'p' or 'i', respectively), and primary and secondary forest types along or directly adjacent to the road is also provided for each carriage road section where applicable.

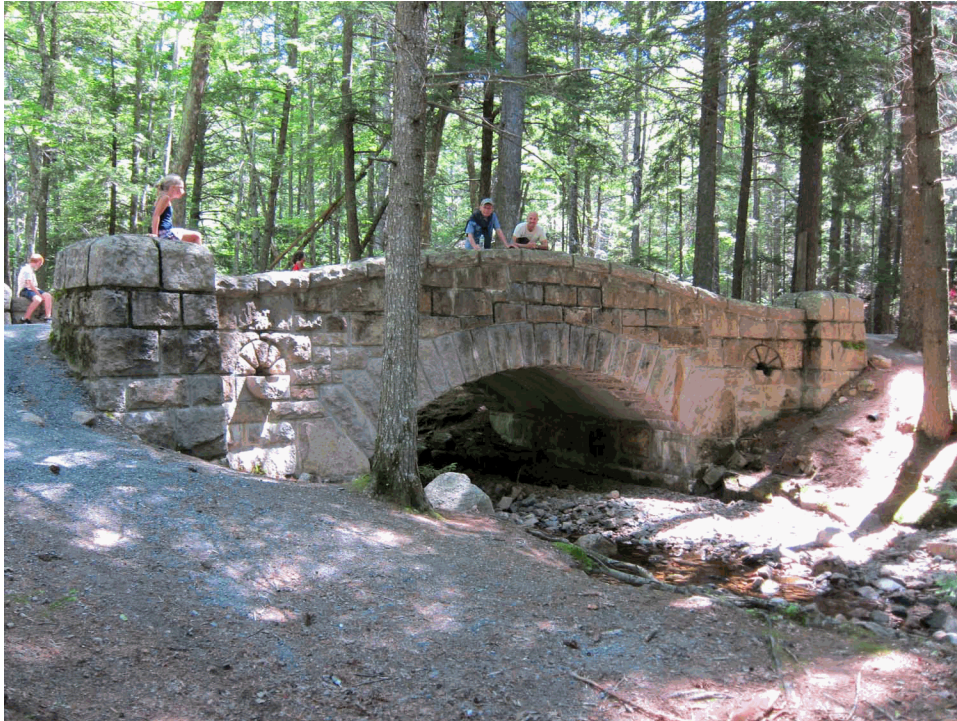
*Figure 20. The Little Harbor Brook Bridge on CR 20-22. (Acadia Week 6, 168, SUNY-ESF, 2012)*

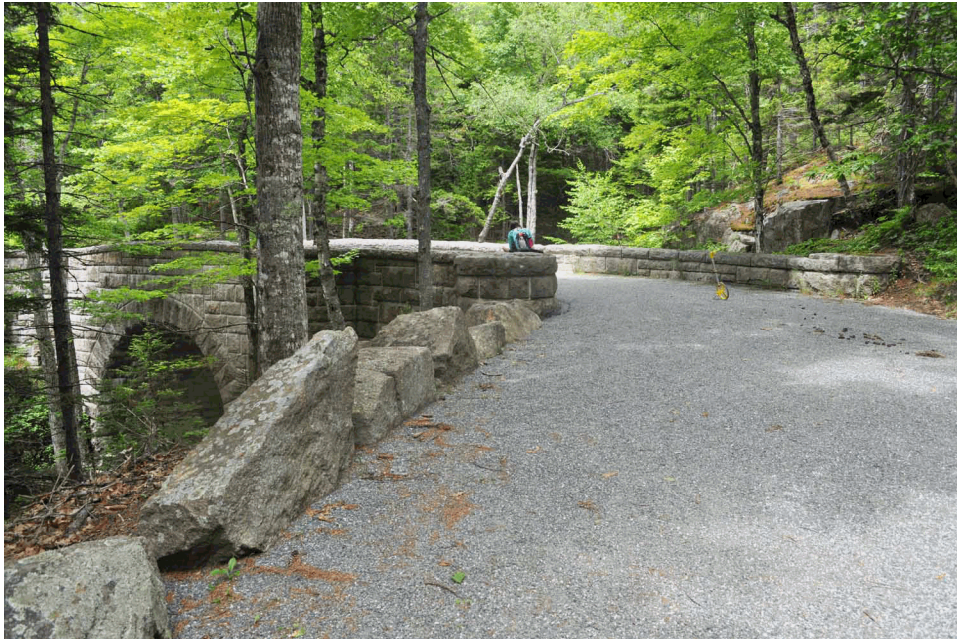
*Figure 21. The Hemlock Bridge (Maple Spring Bridge) on CR 19-12. (Trip 1, ACAD CR 19-12\_1.2809, DSC\_0248, SUNY-ESF, 2012)*

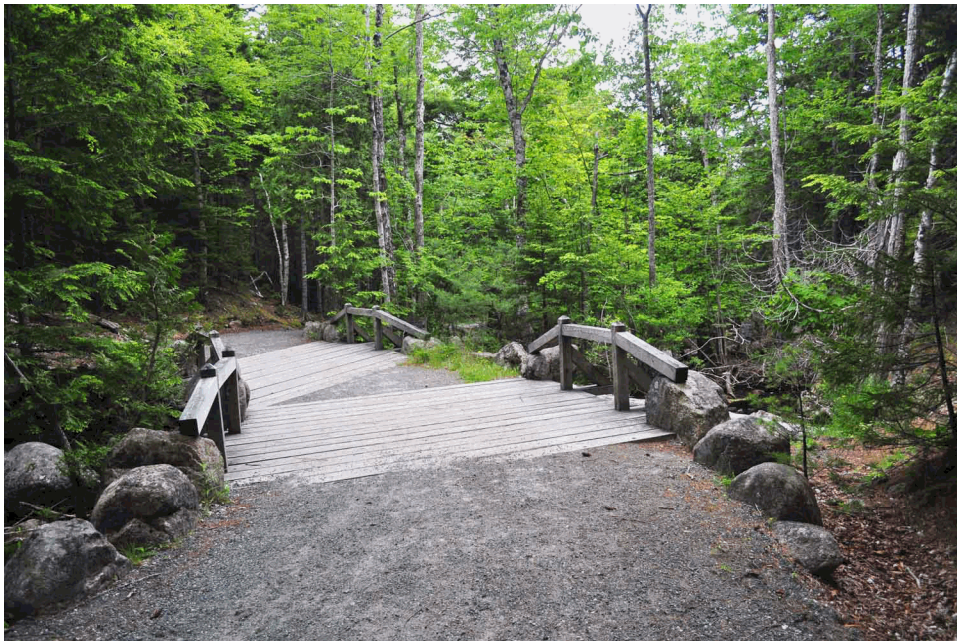
*Figure 22. Bridges #1 and #2, two of the three Jordan Stream Little Bridges on CR 15-23. (Trip 1, ACAD CR 15-23\_0.1229, DSC\_4761, SUNY-ESF, 2012)*

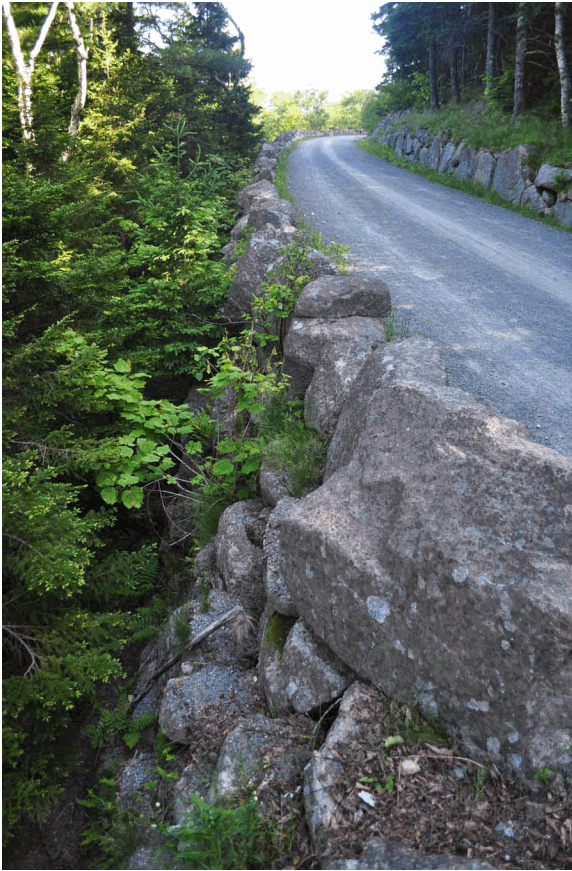
*Figure 23. Retaining wall (image right) and guardwall/retaining wall (image left) on CR 10s-14. (Trip 1, ACAD CR 10s-14\_0.9756, DSC\_4687, SUNY-ESF, 2012)*

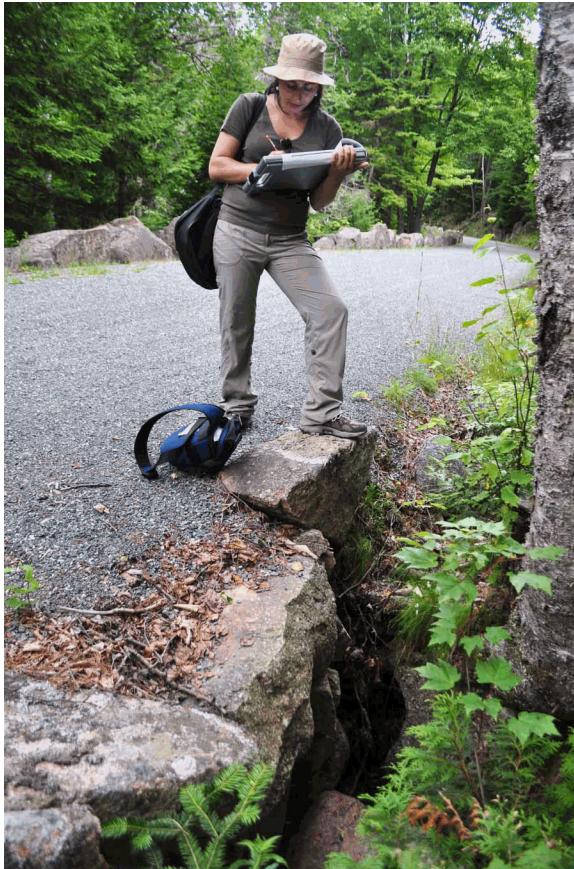
*Figure 24. Stone waterway and culvert inlet on CR 12-10n. (Trip 1, ACAD CR 12-10n\_0.4307-in, DSC\_5243, SUNY-ESF, 2012)*

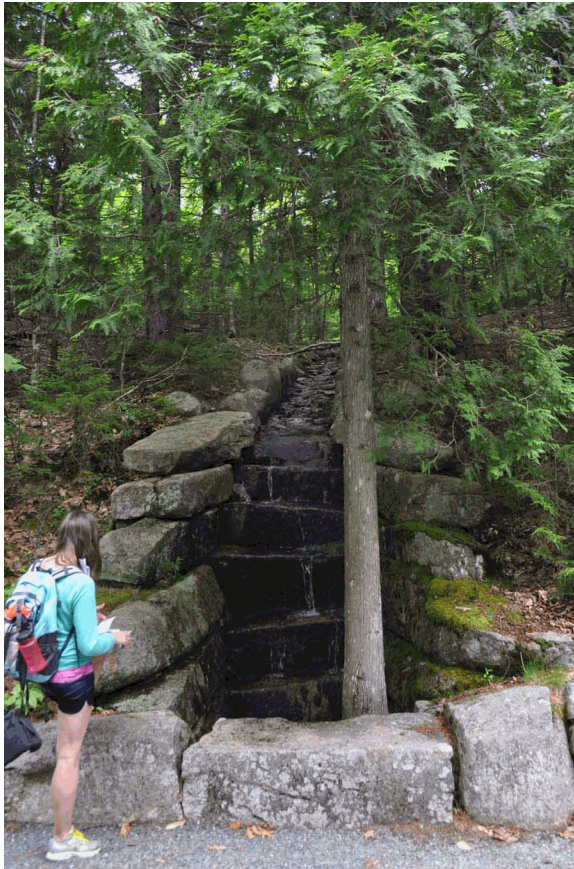
*Figure 25. View of an upper waterway and culvert inlet on CR 19-12, one of the largest waterways in the carriage road system. (Trip 1, ACAD CR 19-12\_1.2394, DSC\_0246, SUNY-ESF, 2012)*

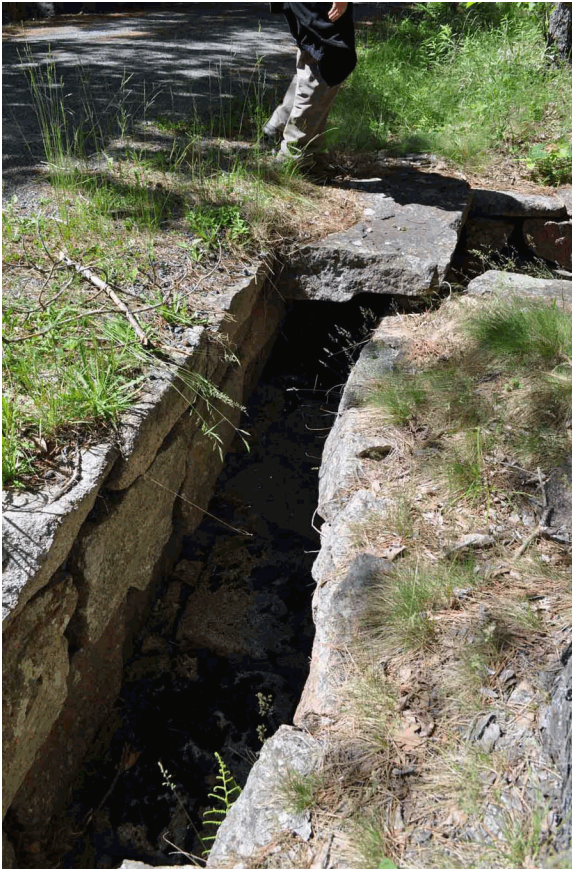
*Figure 26. A stone waterway and culvert inlet on CR 21-20. (Trip 1, ACAD CR 21-20\_0.5750-end, DSC\_0046, SUNY-ESF, 2012)*

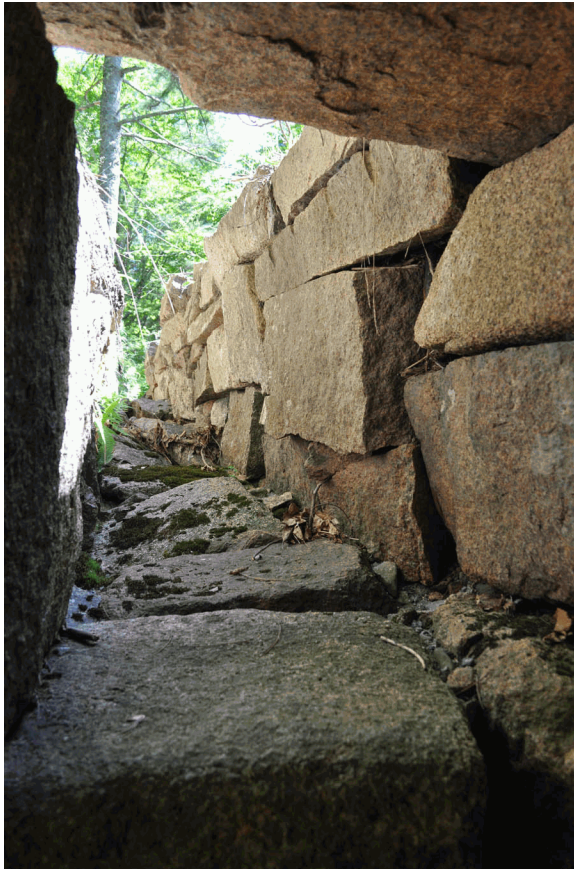
*Figure 27. Detailed view of the waterway shown in Figure 26 on CR 21-20. (Trip 1, ACAD CR 21-20\_0.5750-detail, DSC\_0047, SUNY-ESF, 2012)*

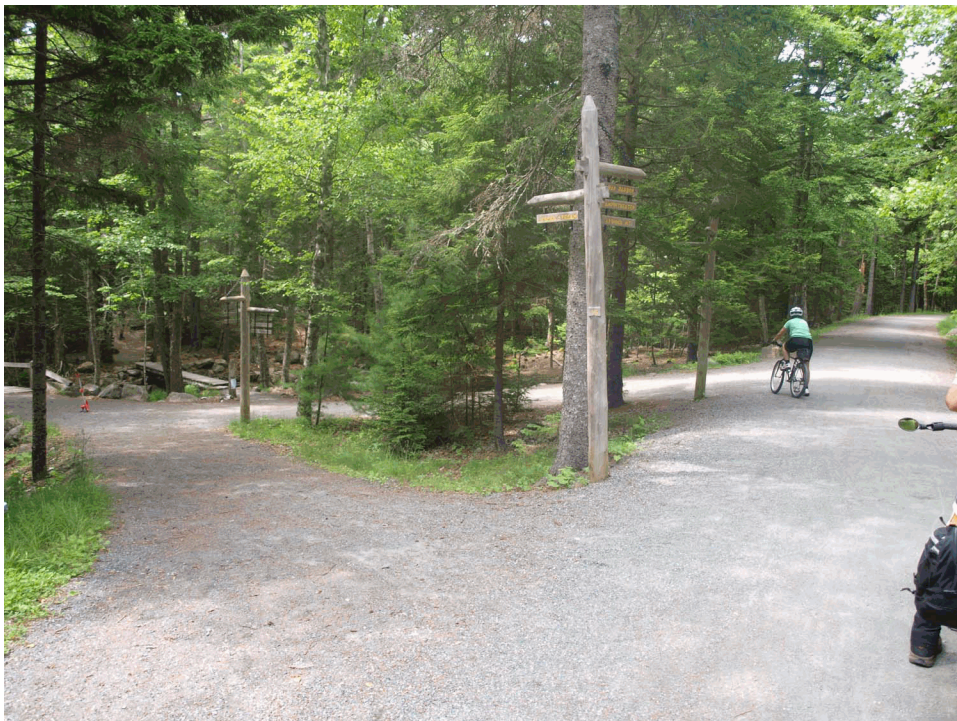
*Figure 31. Typical intersection signpost, at Node 15. (Trip 1, ACAD CR 16-15\_0.1597, P6200676, SUNY-ESF, 2012)*

The park has replaced-in-kind all of the original wood signposts with new ones based on Benjamin Breeze's historic design from the 1930s (Figure 31). Intersections with triangular-shaped island feature three signposts at each point of the triangle, while T-shaped intersections feature one or two signposts along the side of the road. The signposts are constructed with round wood posts that hold pointed round wood arms supported by heavy chain. Hanging from each arm on long metal brackets are individual wood signs with yellow painted letters. The number of individual signs varies depending on the intersection. In the mid-1980s, the carriage road intersections were numbered to help visitors navigate the carriage road system. The small, six-inch square wood signs feature yellow painted numbers and are located at eye-level in carved recesses on the signpost poles. The signposts and signs are in good condition, and are regularly maintained and replaced as needed.
